Cover for *Monuments and the Millennium*, 2001.

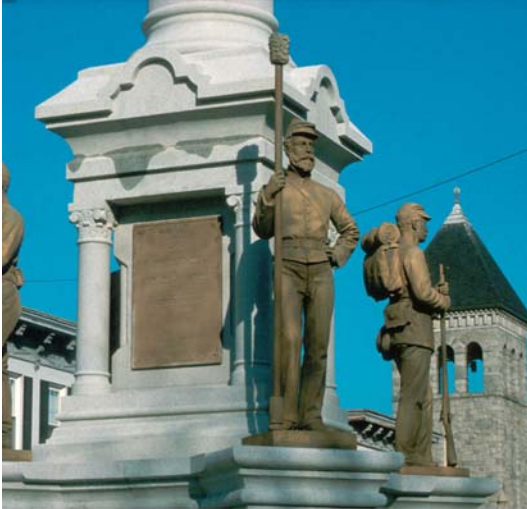
Figure 2 August Zeller, *Schuylkill County Soldiers' and Sailors' Monument*, 1891, bronze & granite, Pottsville, PA. Detail of sandblasted bronze & granite surfaces, 1988. (Montagna)

Let us begin with some conservation history. Concerted efforts to clean outdoor bronze sculpture appear to have been relatively rare in the United States before the early 1970s (Weil 1987). The bronze cleaning that did occur generally used readily available commercial and industrial cleaning methods. Sandblasting and acid cleanings were the most widespread of these methods and usually had a devastating effect on bronze sculpture. Hard, jagged sand particles coupled with the relatively high pressure levels used by sandblasters, or the combination of acid cleaners and scouring, removed virtually all corrosion products, and they did it quickly. The sandblasting that damaged the bronze and polished granite components of the Pottsville Soldiers and Sailors Monument in Pottsville, Pennsylvania was completed in the space of a morning (Fig 2). Typically, these cleanings were carried out not by trained conservators, but by general contractors, by cleaning companies, or by misguided volunteers. These cleanings either left the bare bronze surface to weather once again, or followed by application of a clear lacquer coating or paint. Seldom was the coating properly formulated or adequately applied and maintained. The Hamilton White Monument in Syracuse, New York was sandblasted and coated with a clear lacquer in the early 1970s (Fig 3). Remnants of the unmaintained coating are visible only in sheltered areas visible on the right of the photograph, and the rest of the bare metal surface is corroding anew. By the 1970s, American art conservators, trained in the care of museum objects, had become increasingly

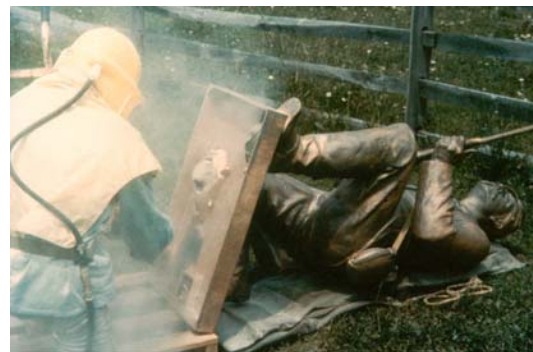
Figure 4 Henry L. Ellicott, *First Pennsylvania Cavalry Monument*, 1890, bronze and granite, Hancock Ave, Gettysburg National Military Park, Gettysburg, PA. Glass bead peening of the monument's bronze figure, 1979. (GNMP Archives)

system by the mid-1970s (Fig 4). While many viewed peening as a gentler alternative to sandblasting, it too was designed to remove all corrosion products from the bronze surface. The system's spherical glass particles, delivered at 60-80 psi, were thought to leave the bronze substrate intact, unlike sandblasting in which a jagged-shaped media, delivered with typically higher blasting pressures, would tear into softer bronze surfaces. Following cleaning, a new chemical patina and a protective lacquer coating were usually applied (Weil 1980). Glass bead peening gained in popularity during the mid 1970s due, in part, to its use as the method for cleaning prominent monuments in New York City's Central Park, Saint Louis, Missouri, and Richmond, Virginia (Fig 5). Within a few years many conservators began to question the concepts behind glass bead peening: that the presence of any corrosion products were inherently harmful and must be removed to effectively preserve bronze statuary, and that the cleaning process itself did not further compromise the bronze surface.

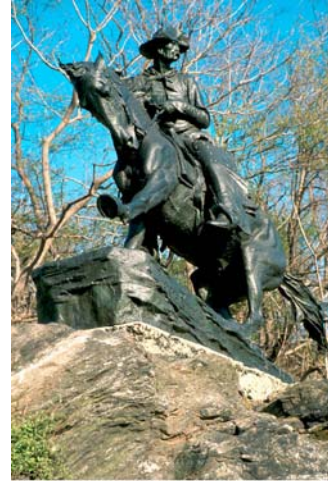
Figure 6 Frederic Remington, *Cowboy*, 1908, bronze, Kelly Dr, Fairmount Park, Philadelphia, PA. View of the sculpture after eight years of annual maintenance of the wax coating, 1990. (Dennis Montagna)

Throughout the 1980s, glass bead peening was supplanted by gentler cleaning methods. The least invasive of these involved a simple soap and water washing, followed by an application of microcrystalline waxes, usually to a heated bronze surface. This became the method of choice for the Baltimore Bronze Project, a conservation programme begun in 1981 (The Baltimore Bronze Project 1989). During the programme's five-year duration, conservators treated 45 bronzes. Two years later, in 1983, the same method was used to clean and coat 25 bronze monuments in Philadelphia (Fig 6) (Bach 1985, Tatti 1985). These cleaning projects depended heavily on adherence to a coating maintenance regimen. Philadelphia's bronzes have been inspected and maintained each spring for the past 15 years.

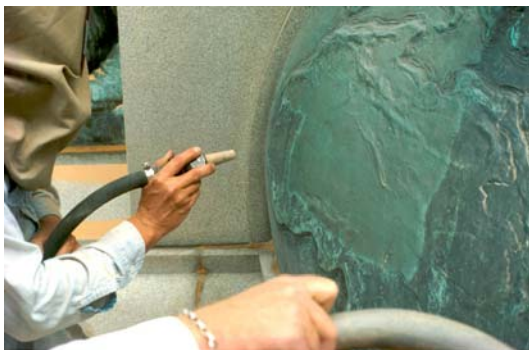
Figure 7 Antoni Popiel, *Brigadier General Thaddeus Kosciuszko Monument*, 1910, bronze and granite. Lafayette Park, Washington, DC. Detail of walnut shell blasting of a corroded bronze surface. The lighter-toned area has been cleaned of dirt and friable corrosion products in preparation for an application of a protective coating, 1987. (Dennis Montagna)

yet gentle, removal of grime and superficial corrosion products. Low-pressure blast cleaning with soft agricultural media strives to leave intact the denser, more firmly-adhered corrosion products and the metal substrate beneath them. Pulverized walnut shells have become the most widely used of the agricultural media (Fig 7) (Montagna 1989, Veloz & Chase 1989). Embodied in this gentler cleaning method is an intent to provide a surface able to receive a renewable protective coating, usually a wax or a lacquer. These less invasive cleaning methods often obviate the need to carry out the extensive surface repatination required by methods that stripped bronzes to bare metal. Typically when hot wax coatings are applied to walnut shell blast cleaned surfaces, they saturate and darken them, often approximating the appearance of a repatinated surface.

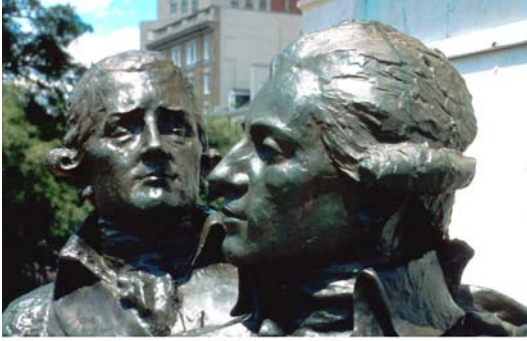
Figure 10 Jean Alexandre Joseph Faiguere and Jean Antonin Mercie, *Major General Marquis Gilbert de Lafayette Monument*, 1891, bronze and marble, Lafayette Park, Washington, DC. Detail of proper right figure group after conservation, 1988. (Dennis Montagna)

Park Service have often not fared much better. A monument to General Lafayette sits directly across the street from the White House. It received a walnut shell blast cleaning and a wax coating that provided protection of the bronze and returned to the work a semblance of the lively reflective surface that it once possessed (Fig 10). But the coating did not receive a timely inspection, washing, and re-waxing, and after three years' exposure in a fairly harsh environment, it is blached, dulled and in need of care (Fig 11).

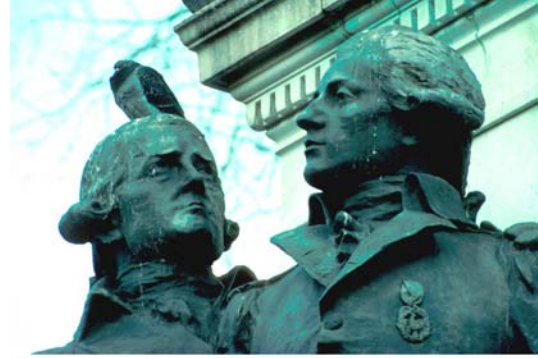
Figure 11 Jean Alexandre Joseph Faiguere and Jean Antonin Mercie, *Major General Marquis Gilbert de Lafayette Monument*, 1891, Lafayette Park, Washington, DC. Detail of conserved proper right figure group three years after treatment, 1991. (Dennis Montagna)

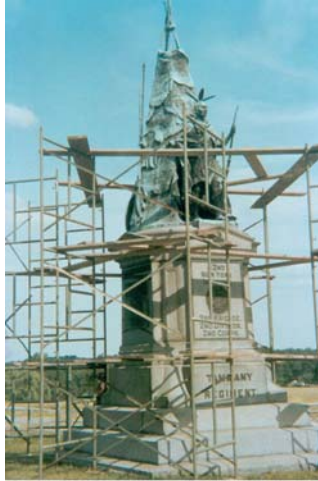
Figure 12 John J. Boyle, 42nd New York Infantry Monument, 1891, bronze and granite, Hancock Ave, GNMP, PA. View of the monument before glass bead peen cleaning, c. 1980. (GNMP Archives)

surface lacquering treatments around 1980. The Tammany Indian of the 42nd New York Infantry was cleaned at that time, depicted here just before and just after treatment (Figs 12 and 13). Those treatments have never been maintained, and, after twenty years, exhibit an advanced state of failure (Fig 14). At this point, they stand in dire need of not merely maintenance, but of extensive conservation. Even with removal of the remnants of the lacquer coating, the visual pulling together of relatively bright surfaces to the more corroded ones on more skyward facing surfaces will require considerable time, skill, and expense. By comparison, other treatments carried out at Gettysburg during the same period were much less invasive. The simple washing and waxing method used in Baltimore and Philadelphia was employed to conserve all of the park's equestrian portraits in 1981 (Figs 15). A photograph of the General Meade Monument, taken in 1996 (Fig 16), shows that these coatings went unmaintained as well, and that the wax coating had completely weathered away from the bronze's most exposed surfaces. At that time, the Park Service's Philadelphia Support Office conducted a training course for new monument maintenance staff to establish an ongoing monument maintenance programme at the park. We selected the Meade Monument as one of our training pieces and used walnut shell blasting to remove remnants of the residual wax coating before applying a new wax coating. Because this monument had not received the invasive cleaning that others at the park had, we were able to bring it back to a maintainable state by using a fairly simple cleaning and coating system.

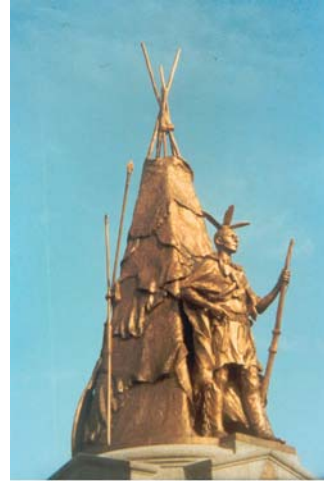
Figure 13 John J. Boyle, 42nd New York Infantry Monument, GNMP, PA, 1891. Detail of the monument's bronze group after glass bead peen cleaning and laquer coating, 1980. (GNMP Archives)

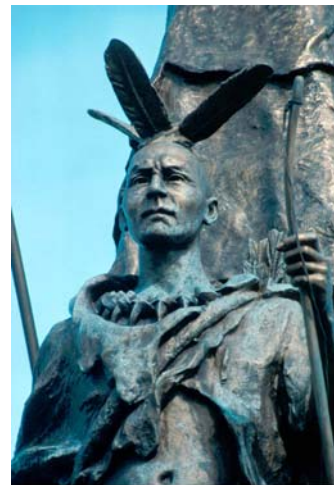
Figure 14 John J. Boyle, 42nd New York Infantry Monument, GNMP, PA, 1891. Detail of the monument's bronze group after eighteen years exposure and no maintenance of the initial treatment, 1998. (Dennis Montagna)

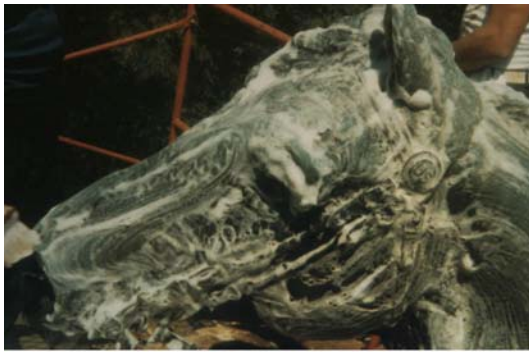
Figure 15 Henry Kirke Bush-Brown, *Major-General John Sedgwick Monument*, 1913, bronze and granite, South Sedgwick Ave, GNMP, PA. Detailed view of the detergent and water cleaning of the bronze surface, 1981. (GNMP Archives)

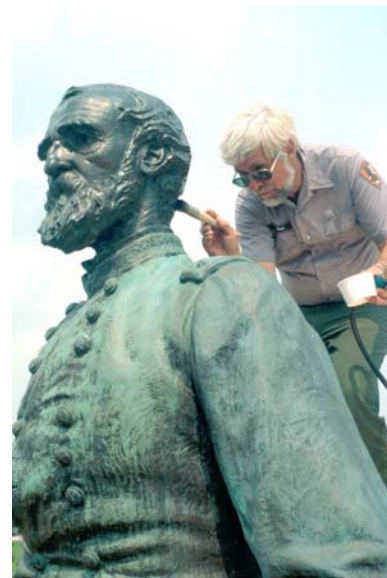
Figure 16 Henry Kirke Bush-Brown, *Major-General George G. Meade Monument*, 1896, bronze and granite, East of Hancock Ave, GNMP, PA. Detailed view of the waxed bronze surface after fifteen years exposure and no maintenance of the initial treatment, during application of an initial wax coat, following walnut shell blast cleaning of the bronze surface, 1996. (Dennis Montagna)

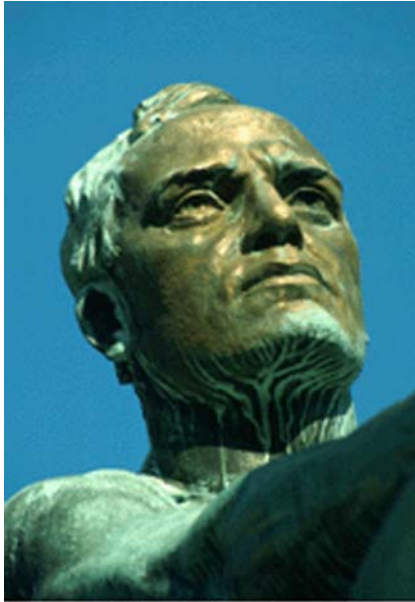
Figure 17 Robert I Aitken, *Samuel Gompers Memorial*, Massachusetts Ave at 10th Street, NW, Washington, DC. Detail of damage to surface caused by abrasive cleaning, 1987. (Dennis Montagna)

Another wrong turn was taken by the American Federation of Labor, when they asked the foundry who had cast their monument to labour leader Samuel Gompers in the mid-1930s to clean it for them in the late 1980s. Their cleaning method of choice utilised power-driven wire wheels with which they began to refinish the surface, much as one would clean and chase a newly-cast bronze (Fig 17). Despite the fact that this treatment was halted before it proceeded very far, and a somewhat less invasive cleaning method instituted, the new dark brown patina that the foundrymen introduced bears little resemblance to the greener patina that the bronze probably carried when it was new.
